Case Studies in Nondestructive Testing and Evaluation

Eddy current analysis of shipped stainless steel heat exchanger bundle

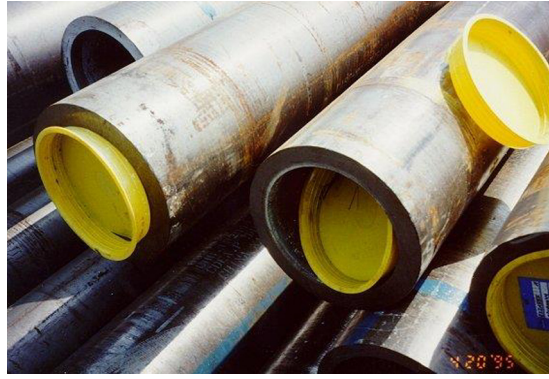
It is common practice for all tubes manufactures to protect both tubes end with plastic caps to prevent the ingress of water and other materials, which can cause damage to the internal tube surface [1], as shown in Fig. 1 below.

Fig. 1. Plastic caps cover at the end of the tube prior to shipment.

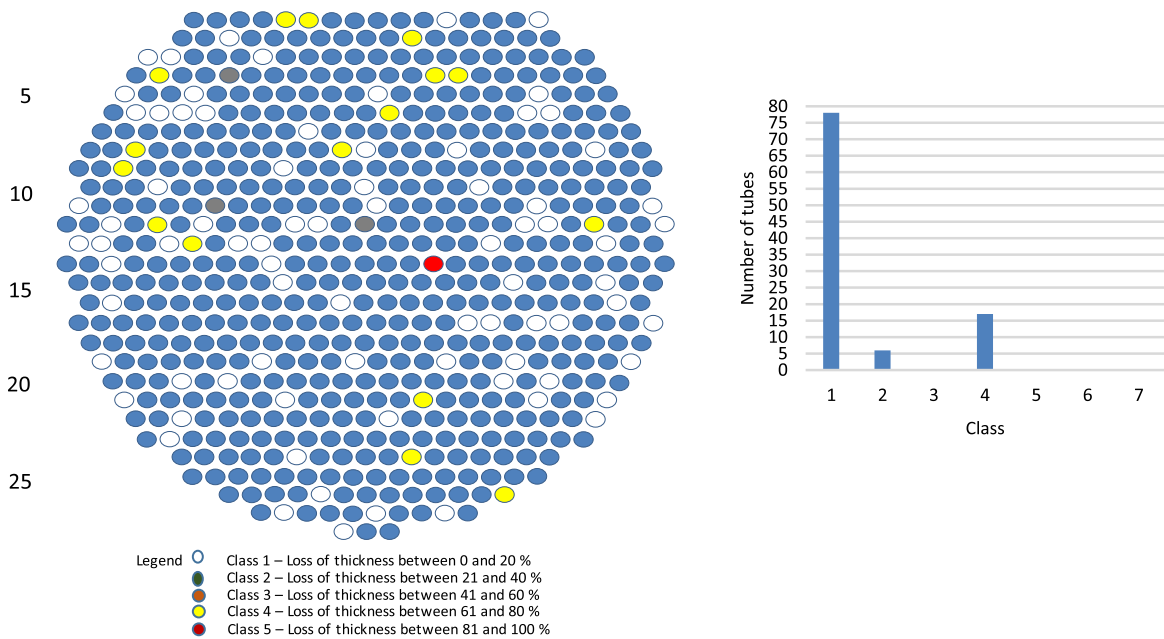
After completion, the heat exchanger tubes inspection shows a loss of thickness to the internal tube surface as shown in the tube sheet in Fig. 2.

The tube sheet map received from Technotest shows many tubes with general corrosion between 0 and 20%, some tubes with general corrosion between 61 and 80%, 3 tubes obstructed and one tube with general corrosion between 81 and 100%.

These results were not expected for new tubes, specially one tube with general corrosion between 81 and 100%, and it required an in-depth analysis by other methods to determine the root failure cause. Aiming to determine the root cause, two tubes were removed from the tube bundle. One of the tubes has no loss of thickness is identified as sample 2 and the other which shows a loss of thickness between 81 and 100% under eddy current test is identified as sample 1. Both samples were put through a mechanical, chemical and metallurgical analysis. The tubes were cut in the middle and examined for indications of corrosion.

Fig. 2. Tube sheet map after eddy current inspection and number of tubes per class.

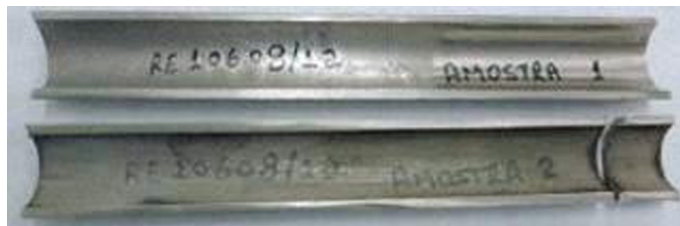
Fig. 3. Identification of samples removed from tube bundle, where no corrosive process is observed but some defects from the mechanical process of lamination are present.

The visual inspection of the tube shows some defects due to the mechanical formation process but no indication of any corrosive process, as shown in Fig. 3. These lamination defects can indeed be a consequence of a corrosive process due to concentration or differential aeration if any solution contains corrosive salts to stainless steel.

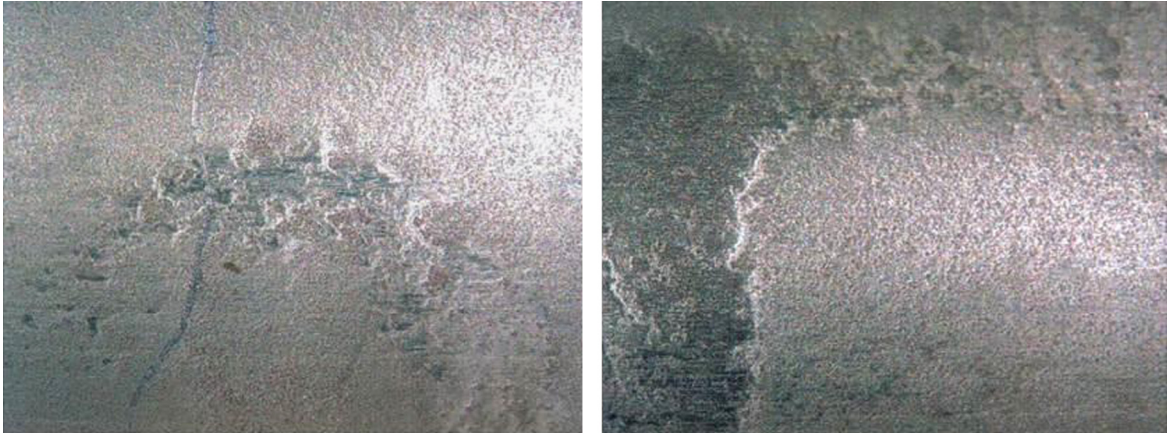
In order to see if there really is no corrosive process under these laminations defects, a macro analysis using a Stereoscopy model SMO-01 was carried out. The macro analysis does not show any corrosive process as shown in Fig. 4.

Fig. 4. Regions of lamination defect without any corrosive process on the internal tube surface of Sample 1.

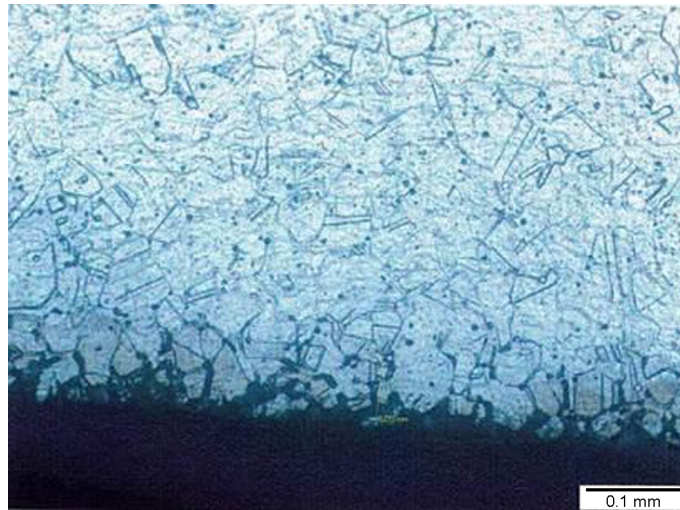
The microstructural analysis from the transverse tube section shows intergranular corrosion in those tubes that present loss of thickness in an eddy current test. The matrix presents some carbide at grain borderlines and shows some carbide in the matrix. The results from microstructural analysis are shown in Fig. 5.

Fig. 5. Micrograph from tube transverse section, 200 X enlarging, acid oxalic etching.

It is known that stainless steel shows good resistance to several media especially those containing chlorides [4]. The presence of carbides in grain boundaries and some sigma phase in the matrix comes from improper solubilisation treatment after manufacturing and welding process [5]. The mechanical and welding process can magnetise the stainless steel and these mechanical magnetisations can cause interference in EC inspection. These carbides and sigma phase appear in

the grain boundaries and matrix when the cooling rating is not sufficiently high to prevent the formation of these micro constituents. The carbides and sigma phase make the stainless steel more susceptible to corrosion and hence reduce the service life of heat exchange tubes when in presence of corrosive media like seawater.

The carbides formed around grain boundaries are in the vicinity of the grains that are poor in chromium rather than the centre of grains. Due to this difference in the chemical composition the carbides become, relative to the centre of grain, anodic because of the halides such as chlorine and will cause intergranular corrosion in this area [6,7].
